**Re: Ameren Missouri
Meramec Power Station
Dewberry & Davis, LLC Coal Combustion Waste Impoundment
Round 7 – Dam Assessment Report**

RE: Ash Pond Dam Stability Analysis
Meramec Power Station

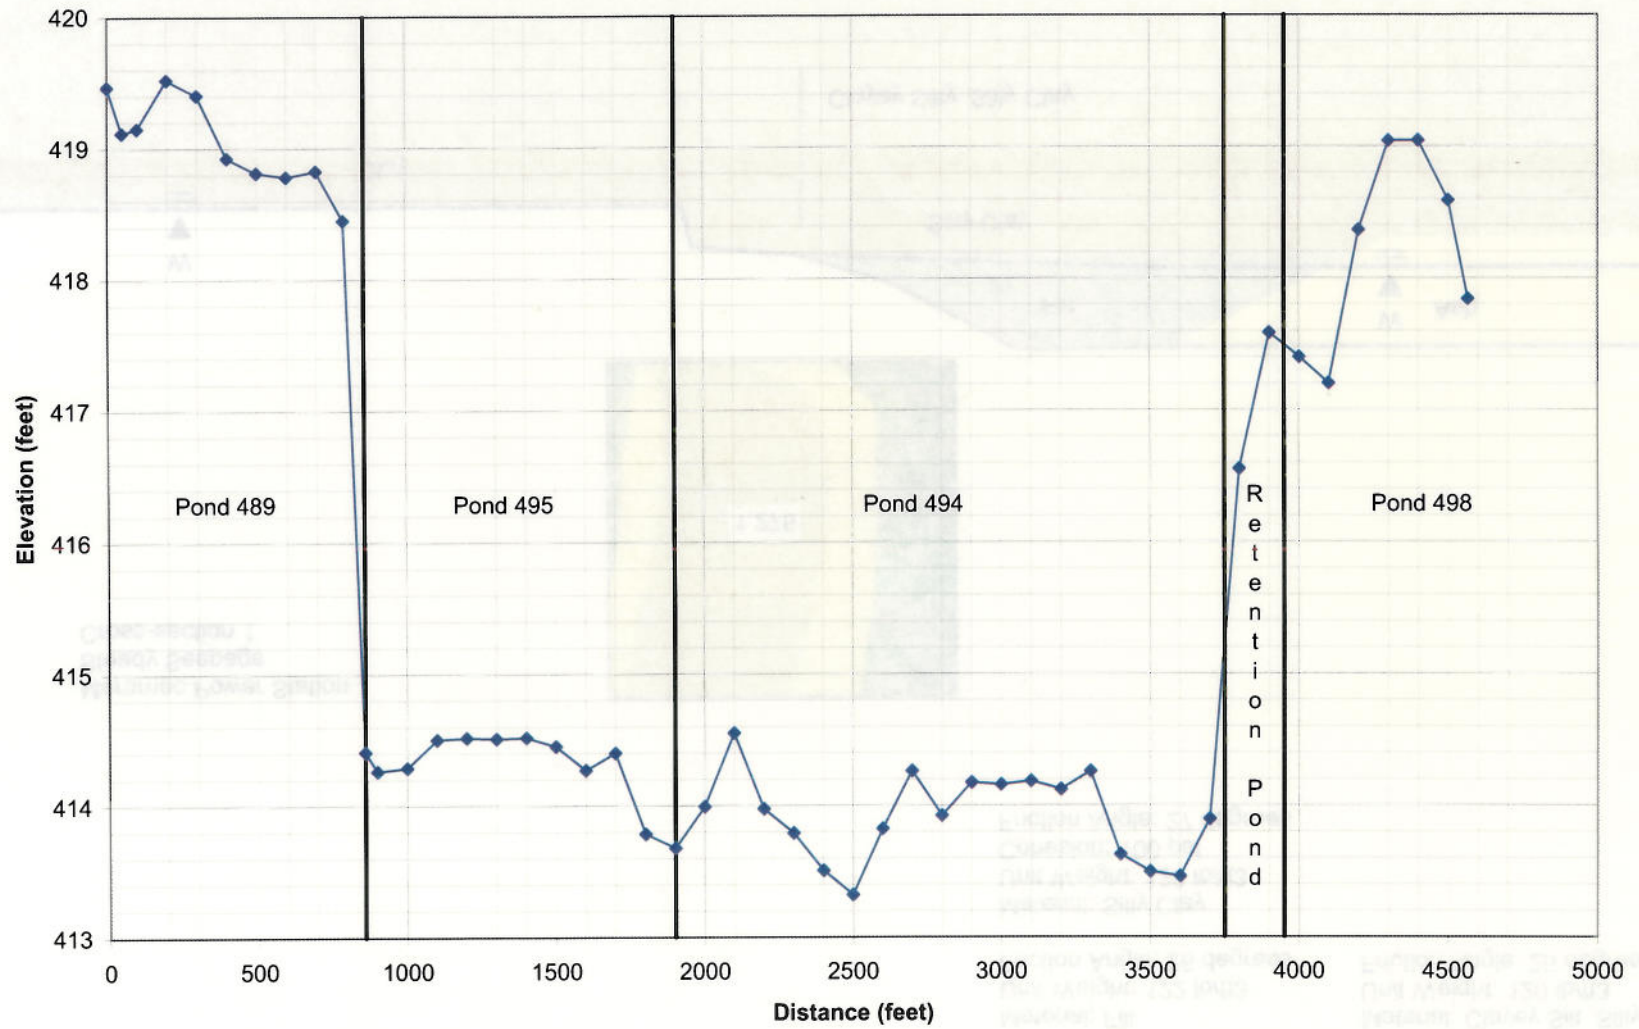
Elevation Profile

An elevation profile was run on the Meramec Dam from the southwest corner of Pond 489 to the railroad track crossing near Pond 493. The total distance of the profile was approximately 4,600 feet and the minimum and maximum crest elevation was 413.3 and 419.5, in that order. A plot of the elevation profile is shown in Appendix C. Five cross-sections were also surveyed and the approximate locations and drawings depicting the sections are shown in Appendix B. The downstream slope angles for the various sections varied from 1.7 (H) to 2.5 (H) on 1 (V). One section was adjacent to Pond 498, 2 were adjacent to Pond 494, and 2 were adjacent to the Retention Pond and Pond 498.
